# Exploring in situ U-Value thermal performance of glazing with infrared thermography for an urban multifamily housing complex

## Abstract

Vibrant is an affordable housing high rise, located in the Pearl District of Portland, Oregon [Figure 1] [Figure 2]. Vibrant was designed to provide affordable and low-income housing to community members [1]. The high-rise apartment complex features 93 units of housing, 40 of these units are reserved from previously house-less tenants, with the remaining 53 units occupied by tenants who live between 30% - 60% of the median income [1].

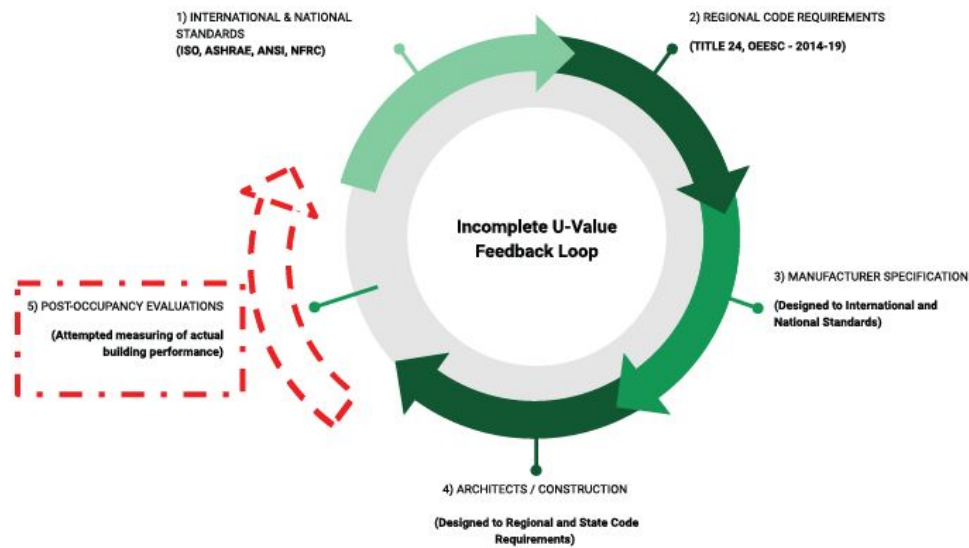
Diagram 1: Incomplete U-value Feedback loop

As [diagram 1] indicates the role of POE within normal industry standards is limited and is not typically conducted leaving the feedback loop of U-value calculations incomplete within industry standards. Through extensive academic research with in-situ methods of data collection researchers are starting to understand the complexities in U-value calculations in real time. The “trickle-down” effect of standardized calculations infiltrate how architects and designers think about building performance. However, the example of U-value calculations can elucidate to other energy performance metrics and values within the construction and architecture industries. If there are large discrepancies in how the A/E/C industries calculate their energy performance for windows this is likely the case for other building materials as well. One of the major limitations for providing and incentivizing POE research is deciding who should pay for evaluations to be conducted. Many real estate investors and building owners would never see a return of investment for a POE study. Furthermore, if the study concluded that the building energy performance was lower than expected, which it might because of the incomplete feed-back loop, then blame might be directed at the architecture firm which can create liability issues along with business relationship challenges.

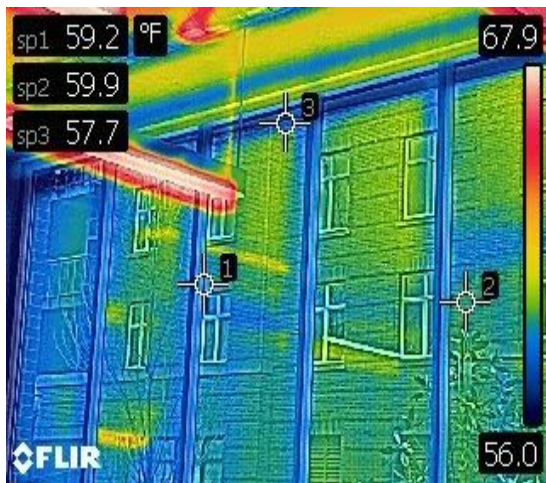
[Image #1]

FLIR Thermal Image: G.L.- Bike

Image #1 and #2 are representative examples of thermal images and regular images taken from both data collection days. Image #1 and #2 were taken from data collection day #1 at G.L. - Bike with a curtain wall window type. Similar images were taken for all of the building program locations specified in [Table 1] and located on [Figure 1] and [Figure 2].

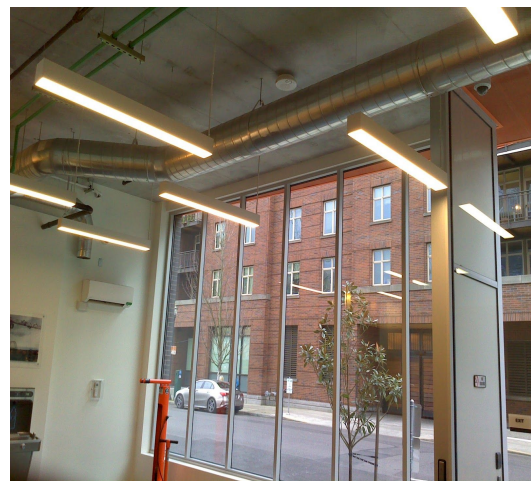
[Image #2]

FLIR Picture: G.L. - Bike

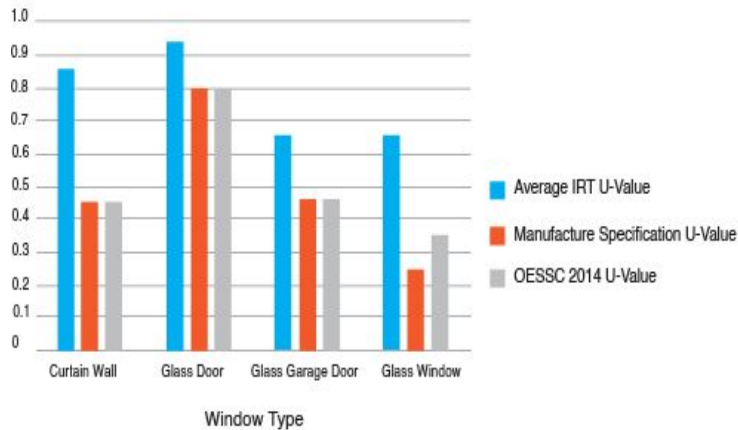
Graph #1: U-value Comparison | IRT, Manufacture and OEESC  
 U-Value Comparison | IRT, Manufacture and OEESC

Graph #1 shows the comparison of U-value calculation using in-situ IRT methodologies compared to specified U-values from the manufacturer and required U-values from OEESC. As indicated in this graph in situ U-values are higher in all window type categories. The largest deviation window type is glass window followed by curtain wall. The smallest deviation in U-value calculations was from the glass door window type.

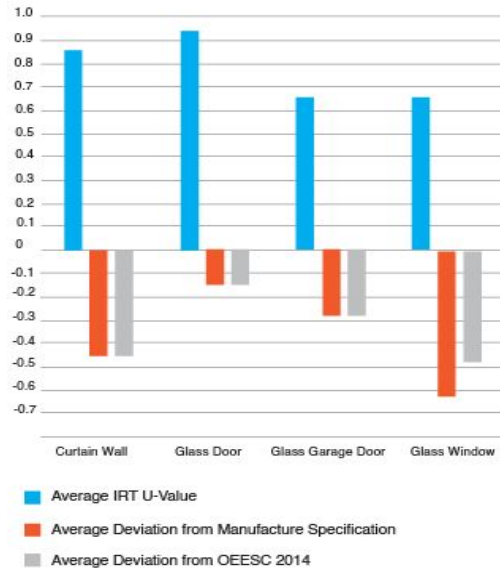
Graph #2: U-value Average Deviation | IRT, Manufacturer, and OEESC  
 U-Value Average Deviation | IRT, Manufacture and OEESC

Graph #2 indicates the average deviation in calculated IRT U-values from manufacturer and OEESC by window type. The largest deviations are seen in window type Glass window followed by curtain wall, with the least deviations in glass door and glass garage door.

Discrepancies in post-occupancy use compared to anticipated occupant usage may be evident for the bike room in general. During data collection day #1, it was observed that L.2. - Bike #2 and L.2. - Bike #3 operable portions of the windows were open. For data collection purposes the windows were closed then a temperature measurement was recorded for both conditions. In addition, during data collection day #2, the same observation i.e. open window was made for both window conditions i.e. L.2. - Bike #2 , #3. Windows were once again closed and then data temperature collection took place. Temperature data results for these two window conditions may be indicative of an abrupt change in temperature. It should be noted that thermal transfer from outside to inside of the building can take many hours to balance out an accurate temperature recording of the inside temperature condition. For the current research this precautionary measure i.e. waiting for a couple hours, was not taken, which may explain large variances in temperature observations along with U-value calculations.

The observation that L.2. - Bike #2, and #3 operable windows were opened, even with a recorded outside temperature of 43° and 46° [Table 2] may indicate occupant behavior patterns about the use of the bike room. Possible implication of these observations may be to create a more desirable thermal comfort level for this particular room within the building or may indicate other occupant usage patterns that were not anticipated during design of the building. A follow up with maintenance staff or occupants i.e. tenants, may allude to reasons why the bike room windows were being opened. It was additionally observed that HVAC units were located directly above and dispersed heated air on the L.2. - Bike #2 and #3 glazing. This might have contributed to the different U-values for these specific windows.

The second largest discrepancy in U-values was from the curtain wall window system. Some possible reasons for this might be that the NFRC and ISO standardization calculations do not take into account the overall size of the glazing. As the curtain wall systems are fairly large compared to a typical window size used in laboratory testing this might explain why U-values for this window type might be higher in in situ measurements compared to theoretical calculations.
